National Transportation Safety Board

Safety Recommendation

Date: January 15, 1998

In reply refer to: A-98-1 and -2

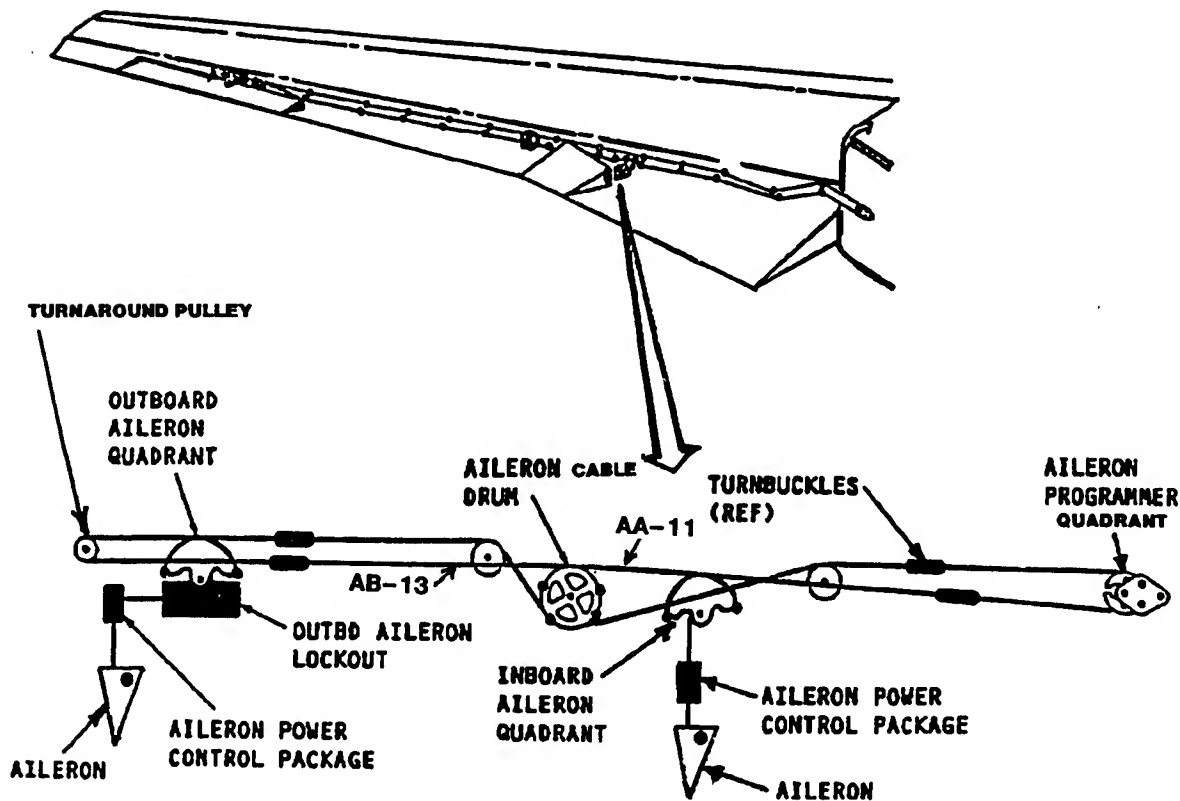
Figure 1. Aileron Wing Control Cable System.

Each wing has two AA and two AB aileron cable assemblies (see Figure 1.), one inboard and one outboard. The inboard AA cable run connects the aileron programmer quadrant to the aileron cable drum, and the inboard AB cable run connects the same quadrant to the inboard aileron PCU quadrant. The outboard AA cable run connects the aileron cable drum to the outboard aileron quadrant, and the outboard AB cable run connects the drum to the same quadrant via a turnaround pulley. The aileron cable drum, which is located at wing station (WS) 776.98, is a four-slotted pulley with a guide pin and is used to provide a complete (closed) cable loop to the inboard aileron even if the outboard segment is lost because of malfunction. The guide pin's purpose is to ensure that all four cables remain in the correct pulley slots at all times.

Further investigation by BASI revealed that the two aileron control cable decals¹ on the aileron cable drum's inboard and outboard mounting brackets at WS767 and WS780 were installed incorrectly. The decal for WS767 was fitted at WS780 and vice versa. BASI also found that a similar 747 aircraft, S/N 23028, production line number 584, had the aileron cable replaced because of excessive wear, and the cable was frayed down to one remaining strand. This aircraft also had the two aileron control cable decals on the aileron cable drum's inboard and outboard mounting brackets at WS767 and WS780 fitted incorrectly and interchanged. Because of the decals' transposition, the Safety Board requested a U.S. operator to randomly inspect its 747 airplane aileron control systems for the aileron cable drum decal identification at WS767 and WS780. An inspection on November 24, 1997, of one 747-251, S/N 21707, production line number 378, revealed similar decal transposition on the right WS767 and WS780.

The BASI investigation concluded that the Brisbane incident was caused by misrouting of cables on the aileron cable drum at WS776.98 and that transposition of the aileron control cable decals on the aileron cable drum at WS767 and WS780 has the potential to cause misalignment of the aileron control cables during installation. The Safety Board is concerned that airplanes with mispositioned aileron cable installation decals may be susceptible to aileron cable failures in flight, which could jeopardize flight safety. The Safety Board believes that the Federal Aviation Administration should issue an airworthiness directive to require operators of 747s, produced before production line number 1130, to conduct a one-time inspection of the aileron control system to ensure correct routing of aileron control cables on the aileron cable drum located at WS776.98 and correct installation of aileron cable decals at WS767 and WS780 at the earliest possible inspection interval.

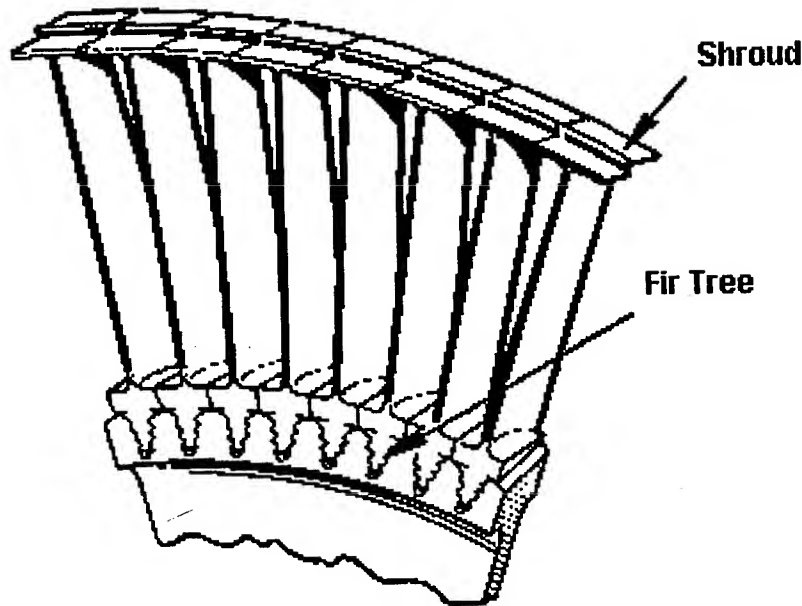
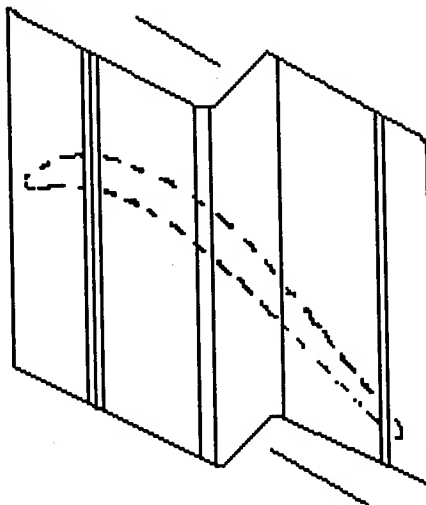
The JT8D LPT blade design incorporates a blade tip shroud for structural support and vibration dampening. The blade shrouds interlock to provide stiffness so that they function as a single ring to reduce blade flexing caused by thermal, aerodynamic and centrifugal loads. The shroud notches (contact areas) are coated with PWA 694, which is a cobalt alloy that is a hard temperature and wear resistant material, to help reduce wearing. Worn shroud notch surfaces reduce blade damping and drop the blades' resonance frequency into the engine operating range. This increases the vibratory stresses to levels that can initiate fatigue cracking.

According to P&W, the JT8D-200 series engine has experienced 180 3rd and 4th stage LPT blade failures resulting from two different failure modes. The first is excessively worn LPT blade notches that can result in HCF fractures occurring at the root of the 3rd and 4th stage blades. P&W indicated that approximately 95 percent of all 3rd and 4th stage blade failures are the result of

worn shroud notches. The second is a low cycle fatigue (LCF)⁴ crack initiating in the 4th stage blade shroud fillet resulting in a cross-notch failure.

Determine the effectiveness of inspection techniques used to measure the amount of shroud wear on installed 3rd and 4th stage low pressure turbine blades on Pratt & Whitney JT8D-200 series turbofan engines, and mandate inspection techniques determined to be most effective based on an interval derived from failure and operational data. (A-98-8)

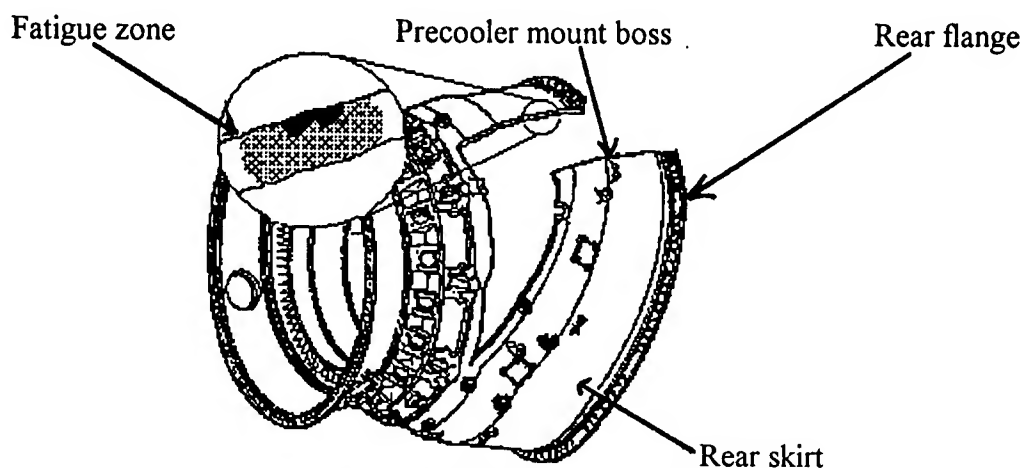
Figure 1: Ruptured diffuser case

A section of the diffuser case rear skirt (see figure 1) was examined at the Safety Board's materials laboratory in Washington, D.C. Examination of the fracture surface, approximately 10 ½ inches from the rear flange, adjacent to the upper precooler mount boss, revealed a 5-inch long discolored high cycle fatigue³ (HCF) zone with about 90,000 striations. The fatigue initiated at a crack that looked like two thumbnail-shaped, gray-colored areas, which were approximately 0.040-inch wide by 0.010-inch deep. High levels of delta phase precipitate⁴ were discovered in the thumbnail-shaped origin areas. Individual 0.0005 to 0.0008-inch deep toolmarks or scratches were found on the outer case wall extending the length of the origin area. Numerous additional toolmarks were found on the exterior surface of the rear skirt. The toolmarks were formed when the exterior surface of the case was machined (blended) during manufacture. The diffuser case had accumulated 9,342 total flight cycles⁵ since new.

A metallurgical analysis of the fracture surface indicated that the thumbnail-shaped cracks had initiated at the base of the toolmarks because of a combination of high residual stresses and low-cycle fatigue⁶ (LCF). The crack then propagated in HCF, as evidenced by the very small striation spacing found in the majority of the 5-inch long fatigue zone, after which the crack progressed to failure in tensile overload.

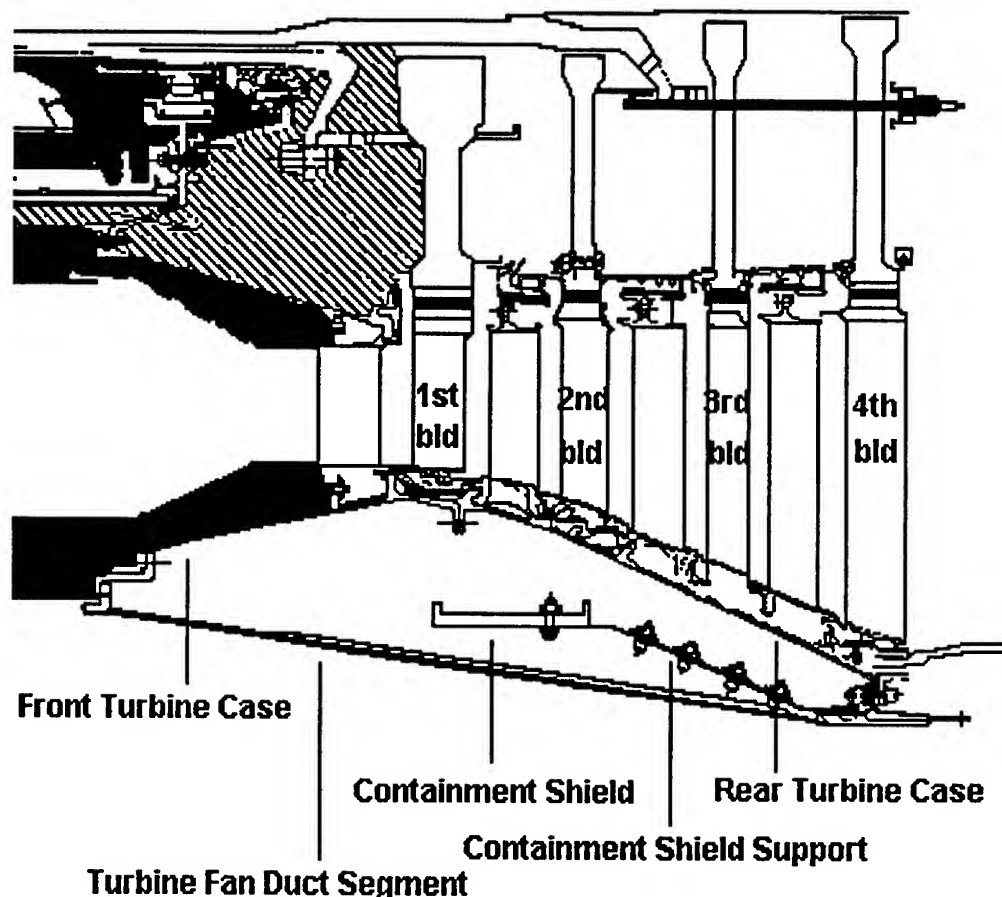
Figure 1 Containment Shield Configuration

applicable to all JT8D-209, -217, -217A, -217C, and -219 turbofan engines. The containment shield is a clam shell design consisting of two half-shields joined by clevis plates and supported by a cantilevered shield support attached to the HPT rear flange. Considerable impact damage (engine debris) was observed on the inner diameter (ID) of the containment shield; however, the shield remained intact. The impact of turbine material on the lower shield shifted it outward and aft from its normal installed position, buckling its support. First-stage turbine blades and 2nd-stage turbine vanes had exited the engine through the openings between the HPT and LPT case flanges and deflected off the containment shield ID while exiting the engine and before striking the airframe.

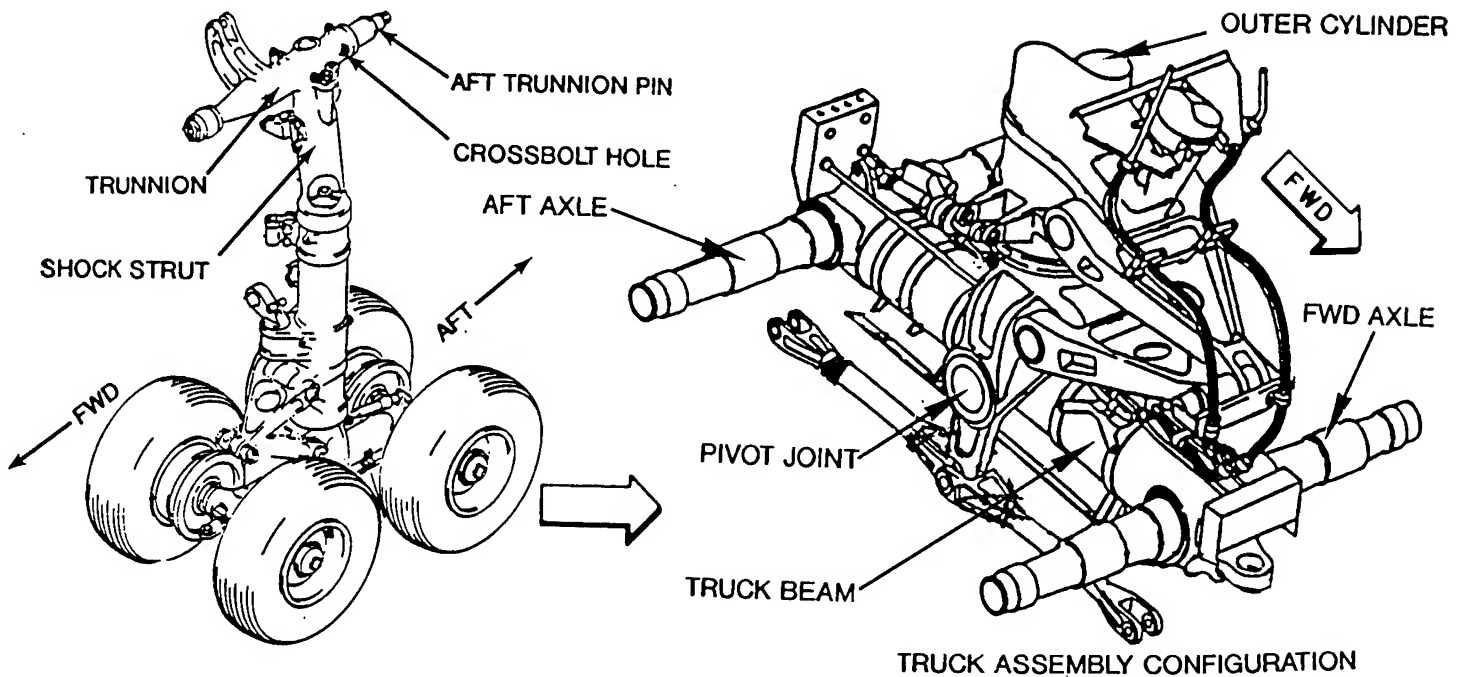
Figure 1. Boeing 757 Main Landing Gear Assembly

The 757 MLG is a conventional, four-wheel, dual-tandem landing gear that has a metering pin orifice shock strut (see figure 1). The gear has four support points: the forward trunnion, the aft trunnion, the drag brace, and the side strut. The shock strut outer cylinder of the MLG assembly transfers operational loads from the truck assembly to the four support points. The assembly consists of a truck beam, axles, wheels and tires, brake rods, and a protective shield. The truck beam is the primary supporting member of the truck assembly. It pivots on the lower end of the shock strut outer cylinder.

The truck beam is a hollow cylinder made from 4340M steel. The inner surface has three primary means of corrosion protection: cadmium-titanium electroplating; Boeing Material Specification BMS10-11 type 1 primer; and MIL-C-11796 Class 1 corrosion-inhibiting compound (CIC), also called Cosmoline. This CIC is applied in a hot liquid form and coats the inner surface of the truck beam with a uniform layer. Any moisture in the truck beam is drained through an opening at the aft end of the cylindrical truck beam section by gravity during truck tilt during takeoff.

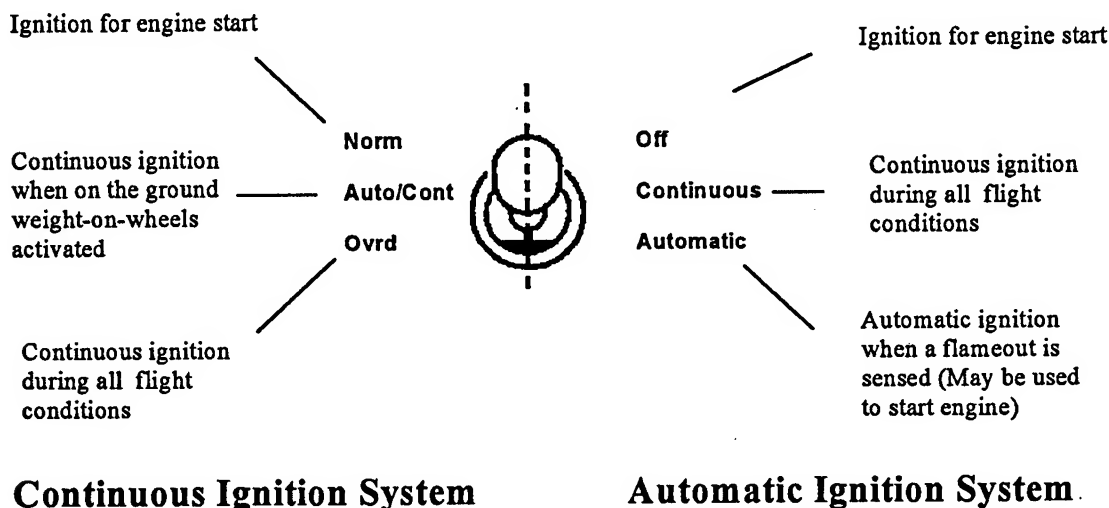
Figure 1. Typical Ignition Switch Position Labeling in TPE331-powered Airplanes

not truly automatic because the pilot must first select an ignition mode using a manually selectable three-position switch. Flameouts can be detected by the decay in certain engine parameters, such as engine revolutions per minute or torque. The automatic ignition system can relight the engine without pilot action or awareness of any engine or airplane performance changes if the ignition mode switch is in the automatic position.
